**United States Air Force
611th Air Support Group/
Civil Engineering Squadron**

Remedial Investigation and Feasibility Study

**Barter Island Radar Installation,
Alaska**

05 JANUARY 1996

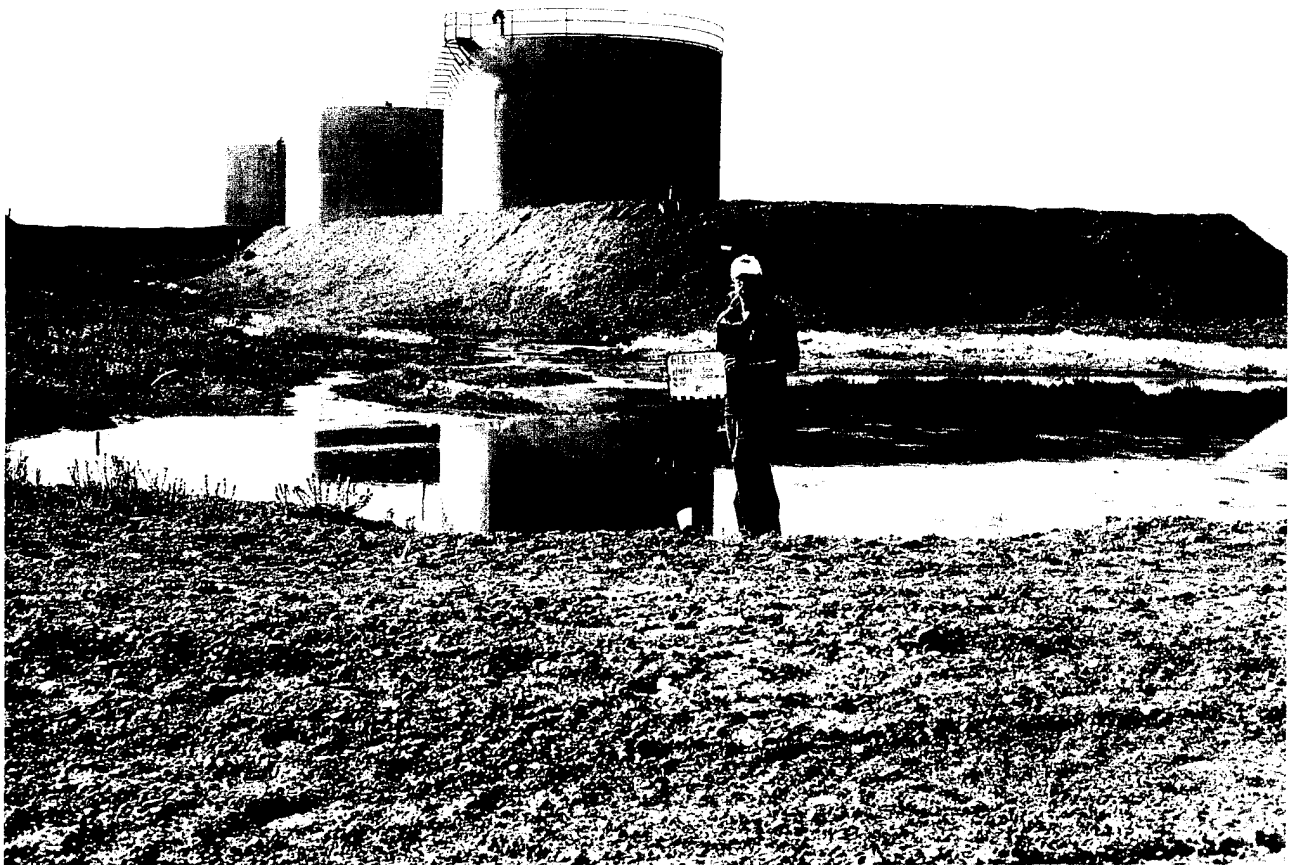
The POL Catchment (LF03) site is a tundra area surrounded by a berm. This is a view to the west from the east berm looking towards the POL Tanks (ST17) site. Note: vegetation (Alaska cottongrass) in catchment basin area not covered with water.

Levels of petroleum compounds (primarily diesel) detected at the site significantly exceed ADEC guidance cleanup levels, and migration of contaminants has occurred. Therefore, the site is recommended for remedial action. The contaminated area at the site consists of 5 cubic yards of gravel and 2,500 cubic yards of tundra. Passive bioremediation is the recommended alternative for remediation of both the gravel and tundra areas of the site.

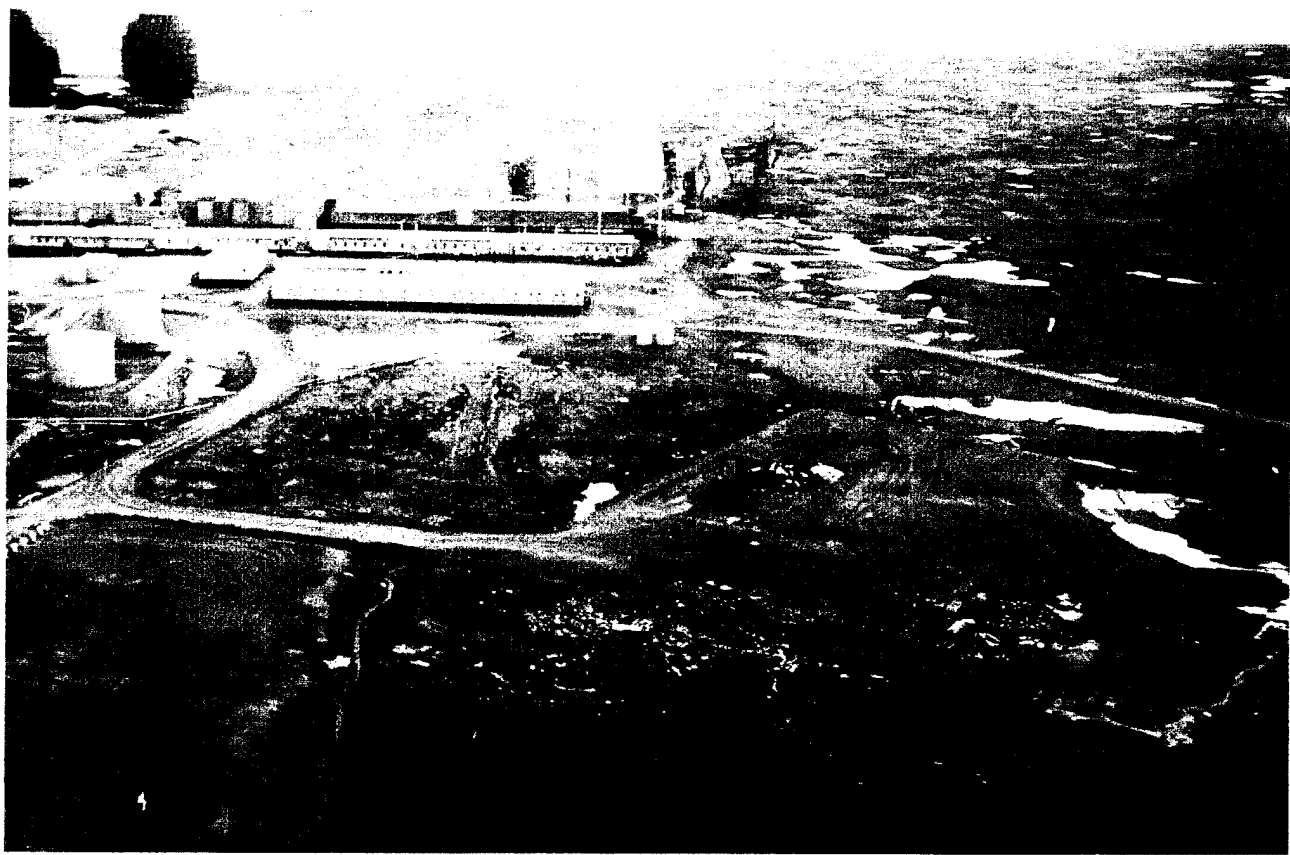
View to the south of the Current Landfill (LF04) site; right side of photo. Debris can be seen scattered along the north boundary of the landfill.

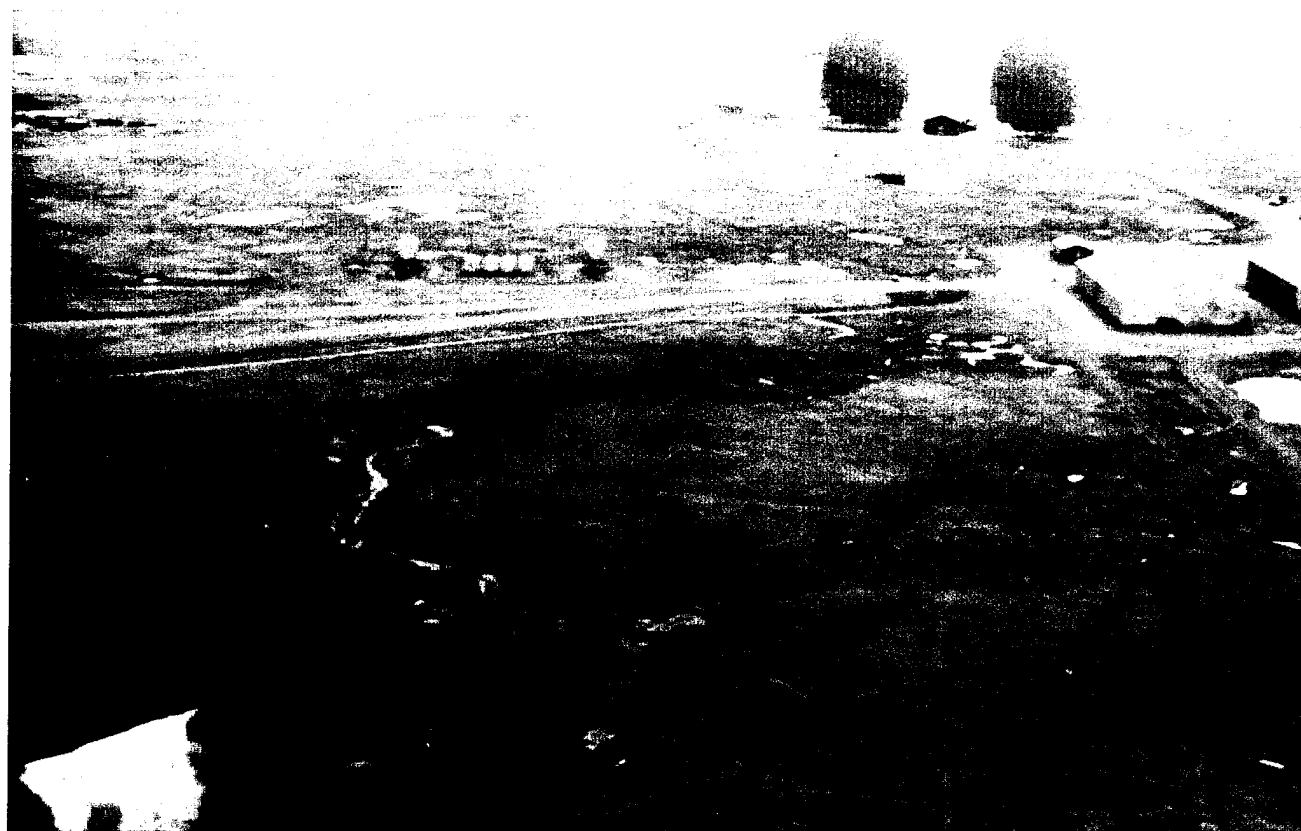
A view to the south of the Contaminated Ditch (SD08) site. The site extends from the bottom left of this photo to the center right. The Old Dump Site (LF19) is located to the left of the Contaminated Ditch in the lower left area of the photo.

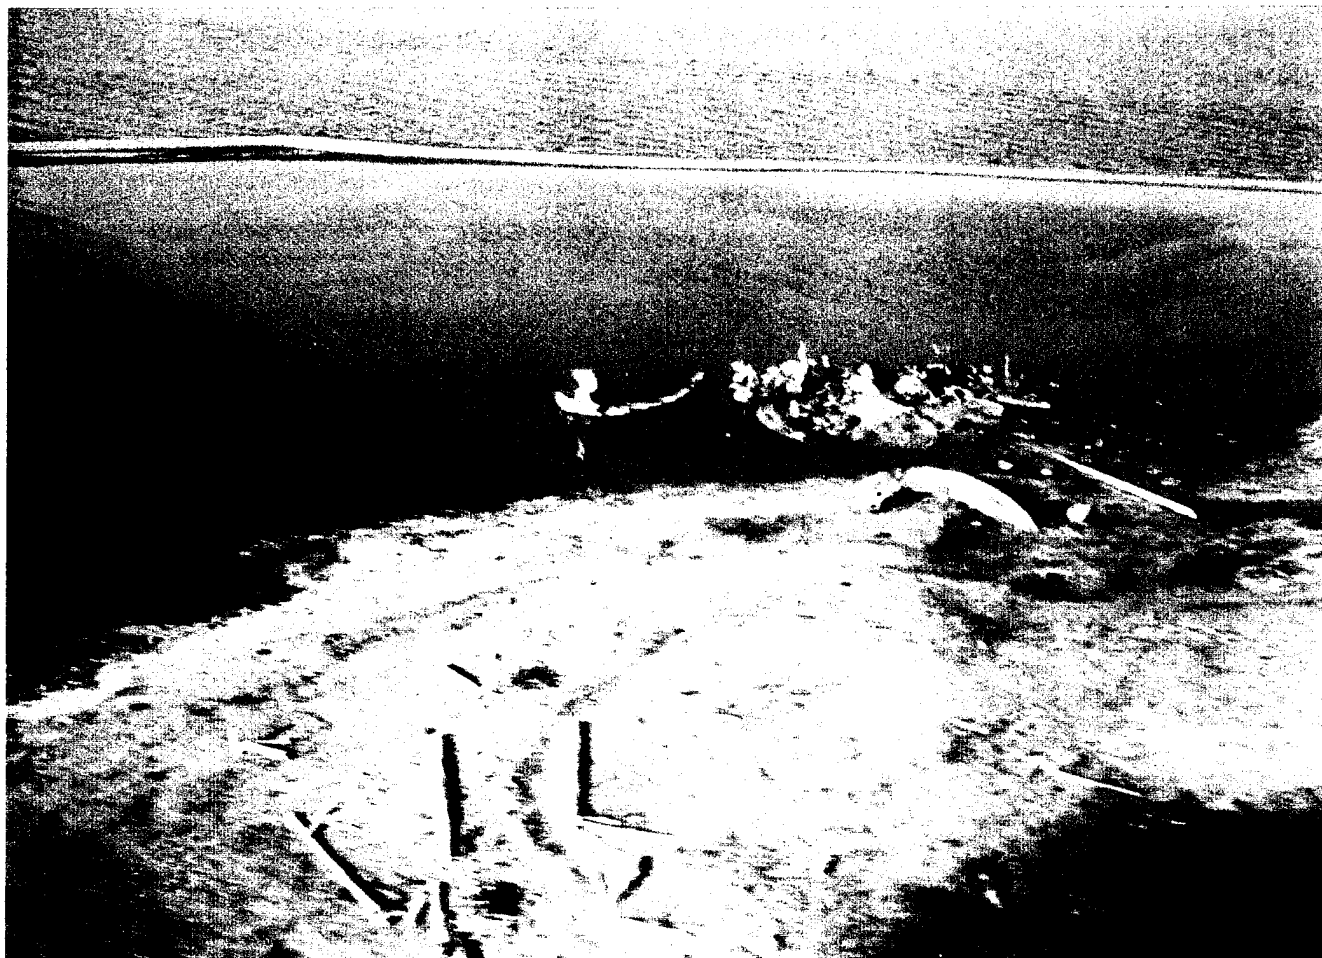
View to the north of the Old Runway Dump (LF12) site. Whale remains are currently dumped here by the local community to deter the polar bears away from the village.

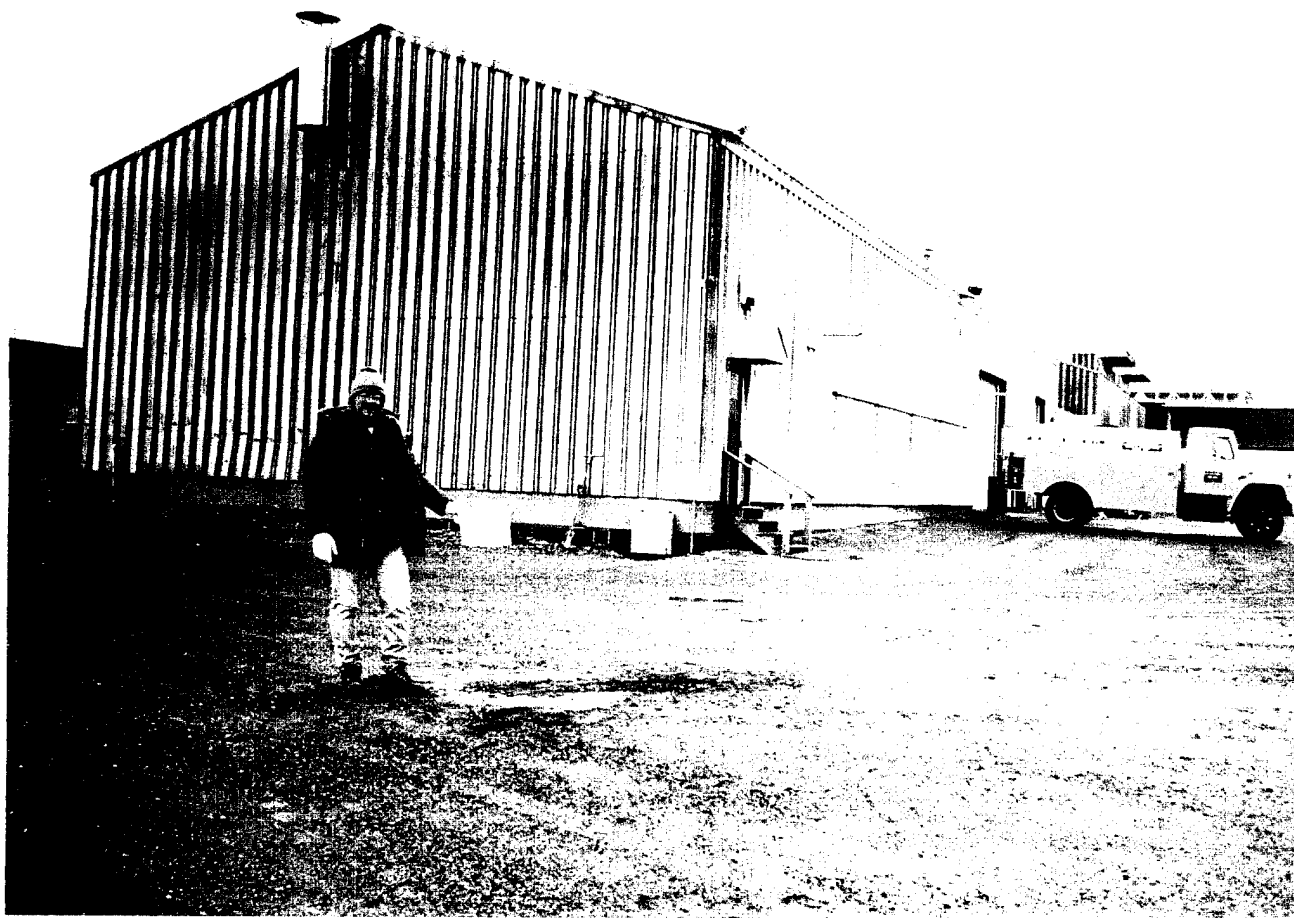
A view to the west of the east end of the Garage (SS14) site.

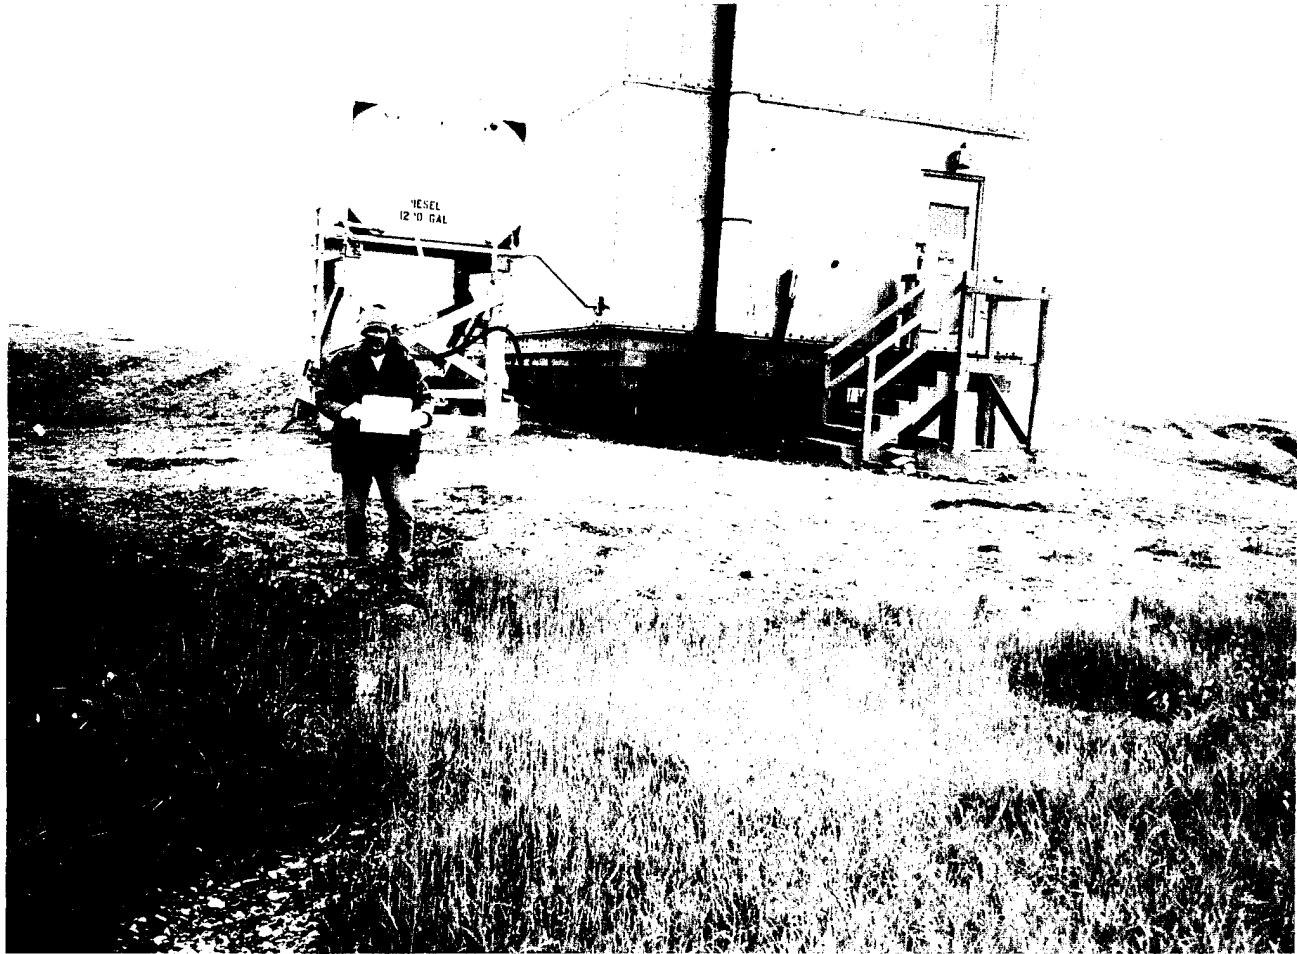
A view to the south of the Weather Station Building (SS15) site. The 1,200-gallon diesel fuel tank adjacent to the building appears to be the source of contamination at this site.

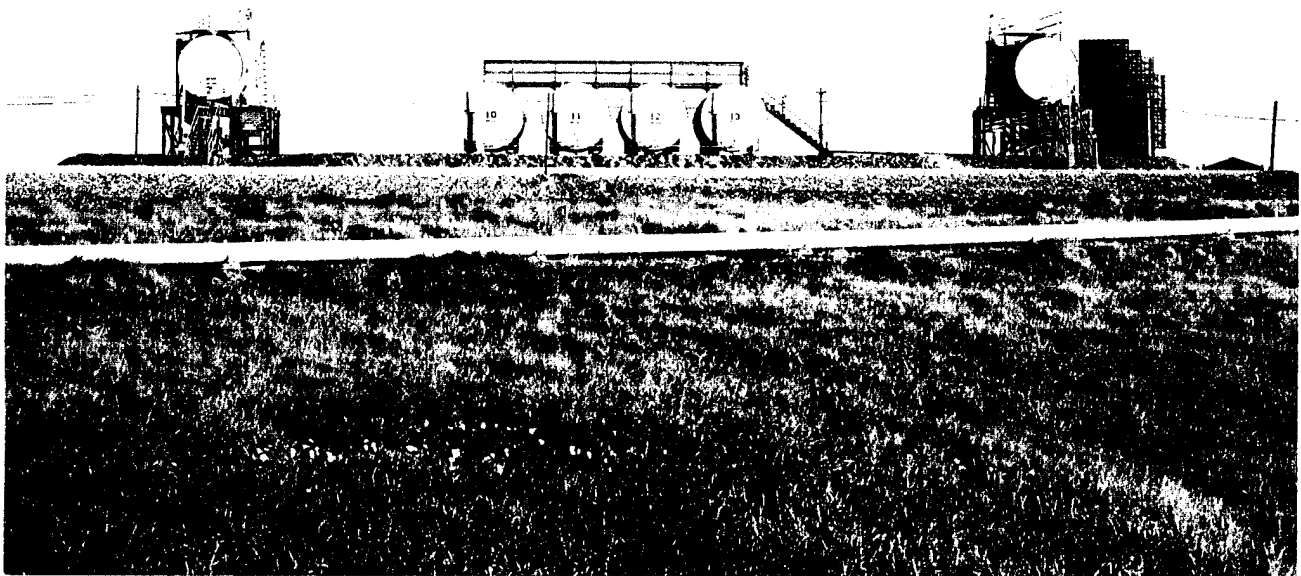
The Fuel Tanks (ST18) are used to store gasoline and diesel. The tanks are surrounded by a berm. This is a view to the south showing the north side of the six storage tanks within the site.

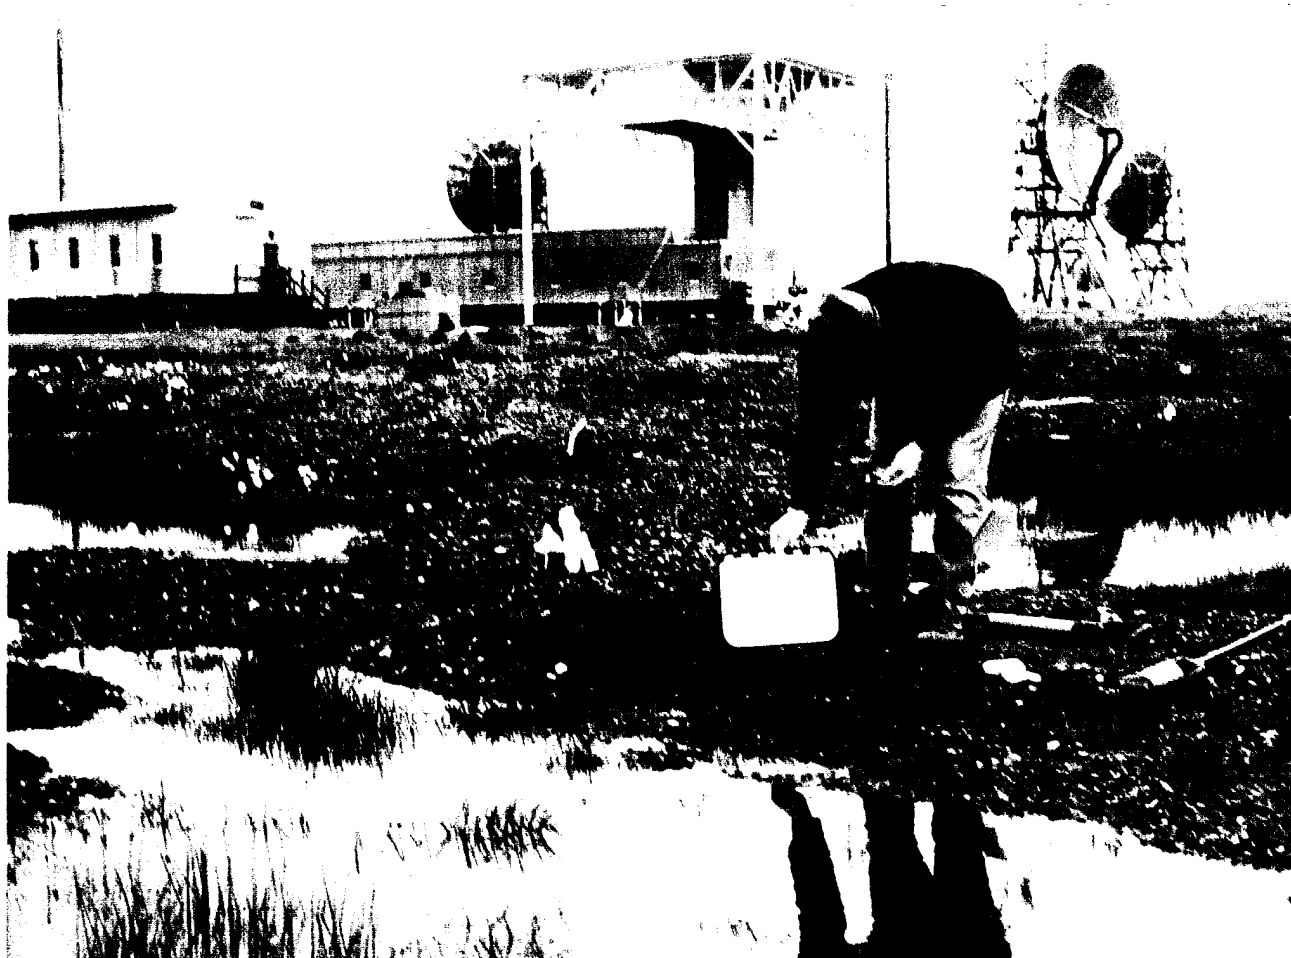
View to the southeast of the Bladder Diesel Spill (SS20) site located just west of module train B. Site personnel reported this area as the location of a historic spill.

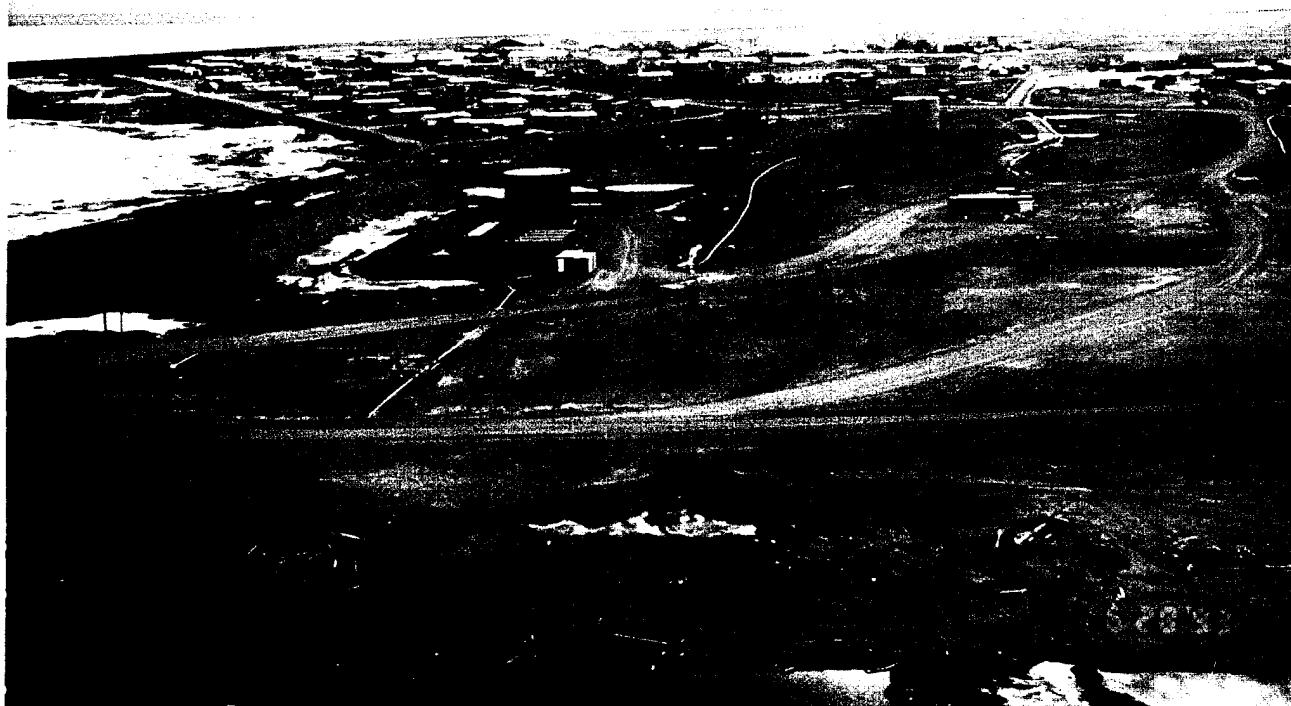
The JP-4 Spill (SS21) site. The arrow designates area in fuel line where the spill occurred. View is to the south with Kaktovik in the background.

Levels of petroleum compounds detected at the site exceed ADEC guidance cleanup levels but the extent of contamination is not clearly defined. Therefore, the site is being recommended for additional sampling in order to more fully characterize the extent of petroleum hydrocarbon contamination.
